**CENTAUR TANK CORROSION
TESTS AND X-RAYS**

**Report Number GD/C-BNZ65-032
1 August 1965**

**GENERAL DYNAMICS
CONVAIR DIVISION
San Diego, California**

This report documents procedures for monitoring, controlling, and preventing spotweld corrosion on present, as well as future, Centaur tank structures.

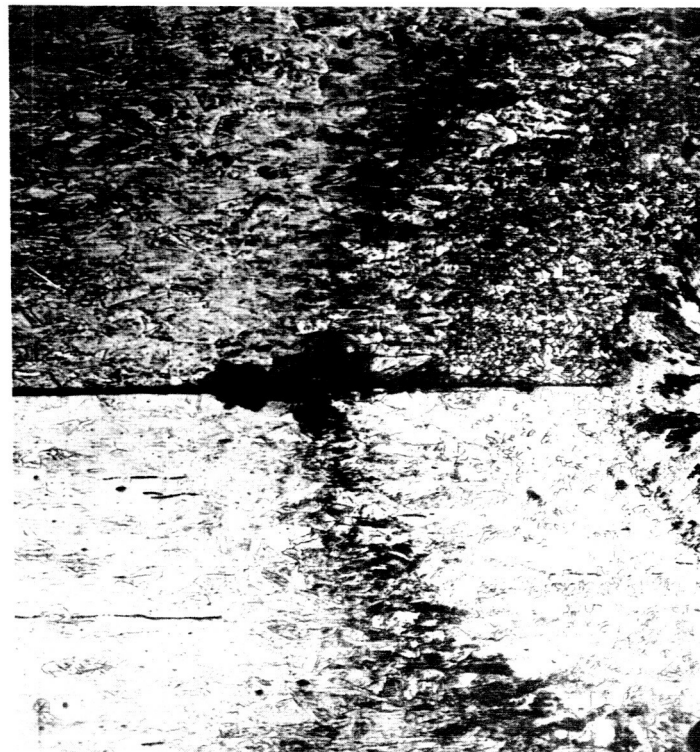
Figure 1-1. Spotweld Cross-Section Showing Corrosion Pit

PHOTOMICROGRAPH OF THE CROSS-SECTIONED SPOTWELD
(MAG. 25X; ELECTROLYTIC OXALIC ACID ETCH).

PHOTOMICROGRAPH AT A HIGHER MAGNIFICATION (100X) OF THE LEFT SIDE
OF THE SPOTWELD SHOWN ABOVE (ELECTROLYTIC OXALIC ACID ETCH).

1.1.3 BACKGROUND INFORMATION. Radiographic inspection is routinely employed to verify the quality of each spotweld during subassembly fabrication and during Centaur final tank assembly operations. X-rays verified that upon completion of each major subassembly operation all spotwelds were free from corrosion defects. Subsequently, the subassemblies were stored until final tank assembly. Following the cryogenic pressure proof test, the tank was subjected to a post-cryo radiographic inspection. Analyzing post-cryo X-rays of 2D (AC-6) and 3D (AC-7) indicated spotweld cracks and pits were developing. Re-X-rays confirmed that the pits and cracks had increased in both quantity and size. Samples of the affected spotwelds are shown in Figures 1-1 and 1-2.

2.1.4 FORMATION. The conditions described in paragraph 2.1.3 result in pits and cracks as shown in Figure 1-1 and 1-2. These branching cracks have been found to be both intergranular and transgranular and are similar in appearance to cracks produced by stress corrosion. They appear to originate as a pit and form cracks due to stresses set up during metal cooling, or could originate as micro-cracks, produced during welding operation, which were attacked and opened up by a corrosive fluid in the faying surface. This fluid may be one of the corrosive processing fluids listed in Table 3-3 which may have become trapped between the faying surfaces before or after the sheets were spotwelded. Corrosion may also have been initiated by non-corrosive solutions combining with salt or other dry corrosive elements, which settled from the atmosphere during tank buildup, forming electrolytes or corrosive solutions.
